Hot Mix Installation – SR 1355

Photos from March 17, 2011. Map 6 - SR 1355 (1.58 miles). 1.5" Lift, Hot Mix. Shoe – NCDOT Prototype 1. These photos are from the first $\frac{1}{2}$ mile of implementation.

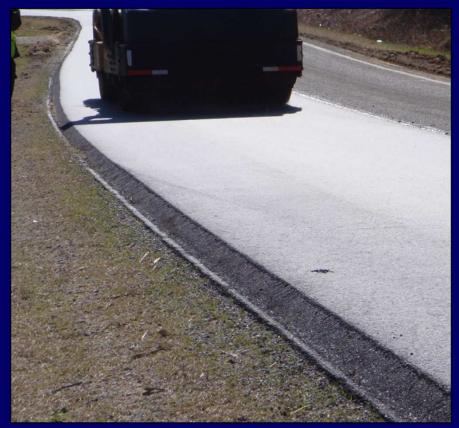
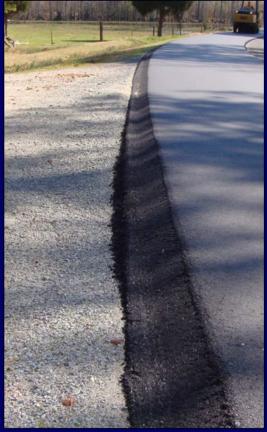
Photos from March 17, 2011. Map 6 – SR 1355 (1.58 miles). 1.5" Lift, Hot Mix. Shoe – NCDOT Prototype 1. These photos are from the first ½ mile of implementation. Notice in the picture on the right how the safety edge shape is in play for most of the slope, however with the depth of the edge drop-off, it causes the asphalt to fall off when it exceeds the safety edge shape.

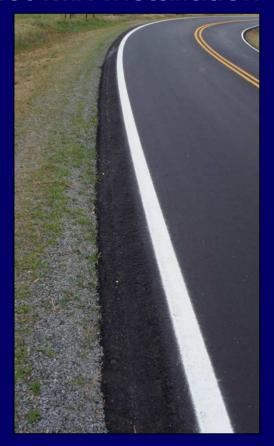
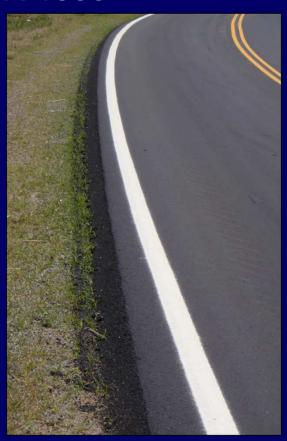
Map 6 – SR 1355 (1.58 miles). 1.5" Lift, Hot Mix. Shoe – NCDOT Prototype 1. Photo on left from March 22, 2011. Photo on right from March 29, 2011. Same curve as shown in previous slide.

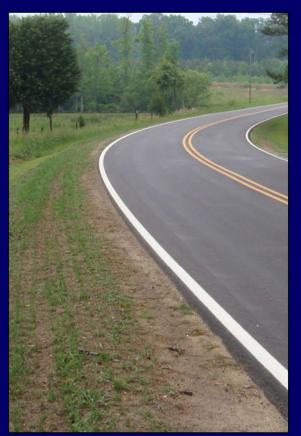
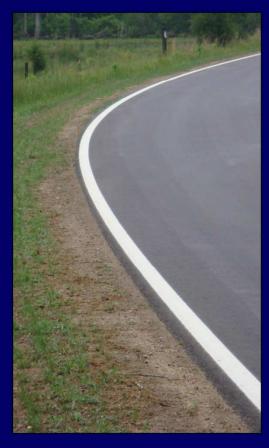
Map 6 – SR 1355 (1.58 miles). 1.5" Lift, Hot Mix. Shoe – NCDOT Prototype 1. Photos from May 11, 2011. Same curve as shown in previous slide.
